**DEPARTMENT OF TRANSPORTATION**

Contract #: 04-0120F4Cty: SF/ALA Rte: 80 PM: 13.2/13.9File #: 69.28**WELDING INSPECTION REPORT****Resident Engineer:**Pursell, Gary**Address:** 333 Burma Road**City:** Oakland, CA 94607**Report No:** WIR-010381**Date Inspected:** 22-Oct-2009**Project Name:** SAS Superstructure**OSM Arrival Time:** 700**Prime Contractor:** American Bridge/Fluor Enterprises, a JV**OSM Departure Time:** 1900**Contractor:** Zhenhua Port Machinery Company, Ltd (ZPMC), Changxing Island **Location:** Shanghai, China**CWI Name:** Sun Bo**CWI Present:** Yes No**Inspected CWI report:** Yes No N/A**Rod Oven in Use:** Yes No N/A**Electrode to specification:** Yes No N/A**Weld Procedures Followed:** Yes No N/A**Qualified Welders:** Yes No N/A**Verified Joint Fit-up:** Yes No N/A**Approved Drawings:** Yes No N/A**Approved WPS:** Yes No N/A**Delayed / Cancelled:** Yes No N/A**Bridge No:** 34-0006**Component:** OBG Crossbeams**Summary of Items Observed:**

## WELDING INSPECTION REPORT

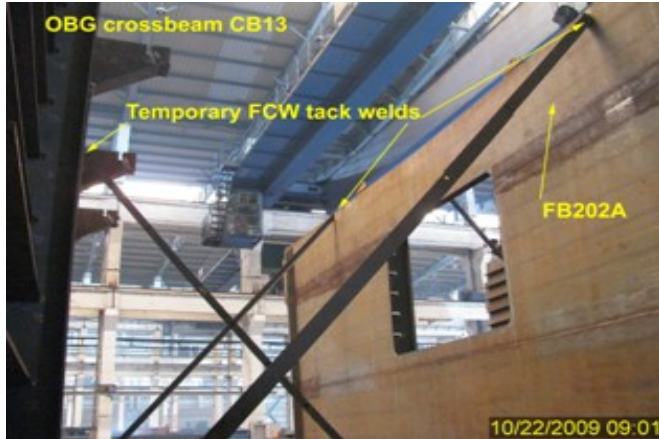
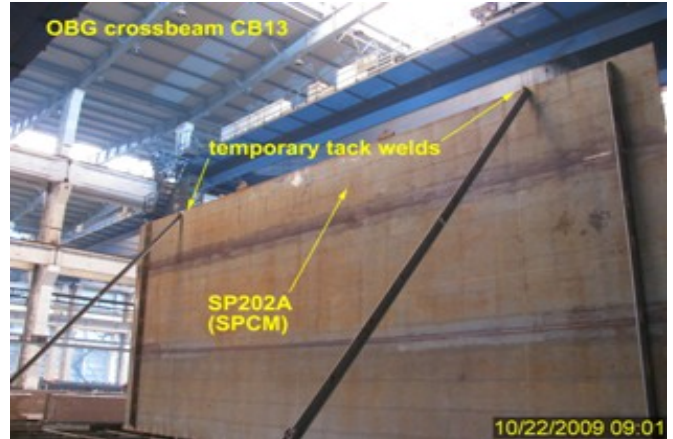
This Quality Assurance Inspector (QA) observed the contractors welding personnel tack weld a temporary fixture to the SPCM portion of the east side panel of crossbeam CB13. The SPCM is identified as SP202A. This QA observed the worker did not preheat the material prior to tack welding. This QA also observed that there did not appear to be an applicable WPS available for review. This QA noted that the contractor has previously tack welded three (3) temporary fixtures each on SPCM panels identified as SP205A and FB202A. See attached photos for details. AWS D1.5 2002 section 12, table 12.2 requires FCW tack welds outside the joint to be performed to an applicable WPS and the minimum preheat to be per table 12.3, 12.4 or 12.5. AWS D1.5 section 12, table 12.3 specifies the minimum preheat shall be 40 oC to 100 oC depending on the calculated heat input and the diffusible hydrogen of the electrode. This QA notified ZPMC QC CWI identified as Mr. Sun Bo and ABF QA inspector identified as Mr. Zou Hu of this issue and that an incident report would be generated.
